# 2

## Cases of Machinery Failure

### 2.1 The Cases

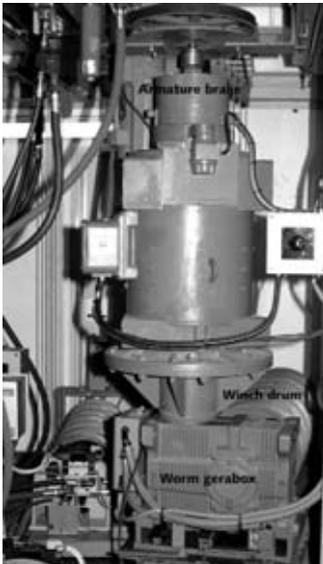
Figure 2.3 A winch motor and gearing system. The motor drive is attached to a worm gearbox

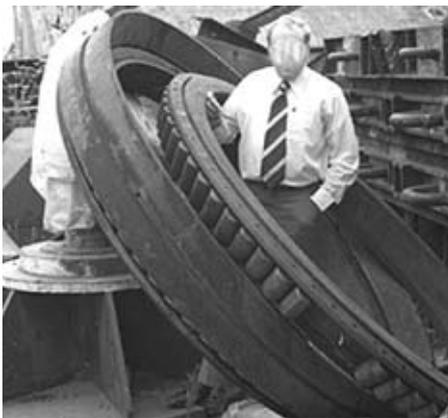
Figure 2.10 Broken main bearing of the MRTA tunnelling machine

Using even the smallest estimated moment ( $3 \times 10^6$  Nm) acting on the bearing, the flexure of the retainer ring permitted the bearing to deflect by approximately 2 minutes of arc. This value exceeded the manufacturer's safe recommendation of 0.5 minutes of arc by a factor of four for about 65% of the operating time. The rest of the time the flexure was greater than this conservative value. It was estimated that the outside edges of rollers in the front row of the bearing "rode" on the front lower part of the cup that eventually broke away, permitting the head to fall off.

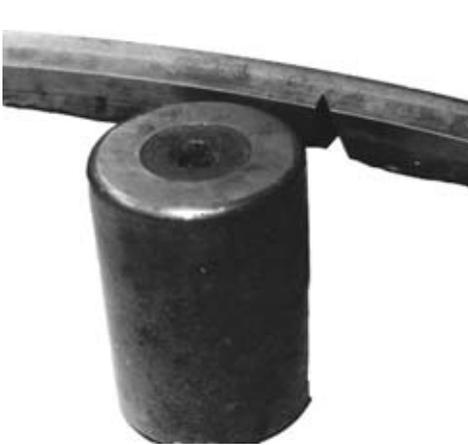
Figure 2.12 Bearing roller and part of the failed bearing cup. The notch was used for establishing material properties

A small sample of bearing material was taken from the broken section of the bearing and examined by a metallurgy laboratory. It was found to match the maker's specification for this bearing. Having reviewed the operator's log and the bearing material it was now necessary to estimate bearing life and operating loads.

Figure 2.12 is a close-up of a bearing roller, together with part of the bearing cup that broke away during the failure of the bearing. Figure 2.13 shows the complete broken part of the bearing cup representing approximately  $120^\circ$  of arc or about the arc length corresponding to 1/3rd (16) of the total number of bearing rollers (this bearing had 48 rollers in each row).

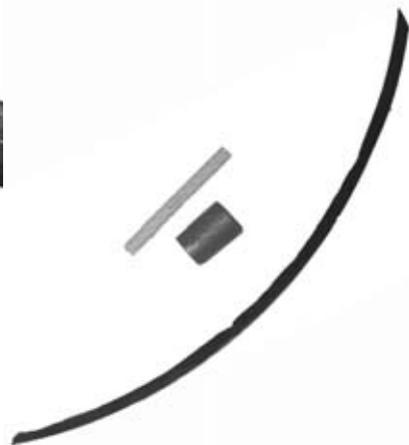
Figure 2.13 Part of the bearing broken away during the accident, with a roller and a 300 mm ruler to indicate scale

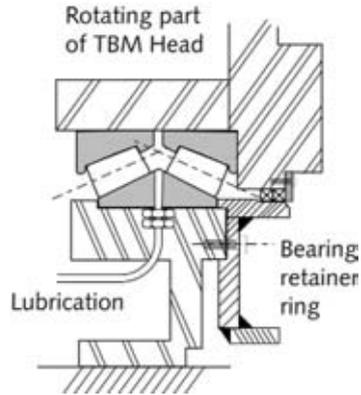
Figure 2.15 Original design of bearing mounting. This partial view shows the relatively flexible retainer ring

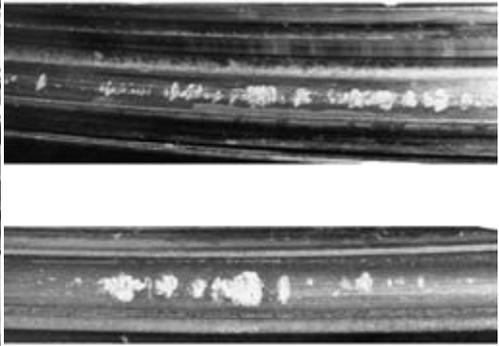
Figure 2.22 Bearing damage. The upper photo shows the damage to the inner (fixed) race. The lower photo is that of the damage to the moving (outer) race

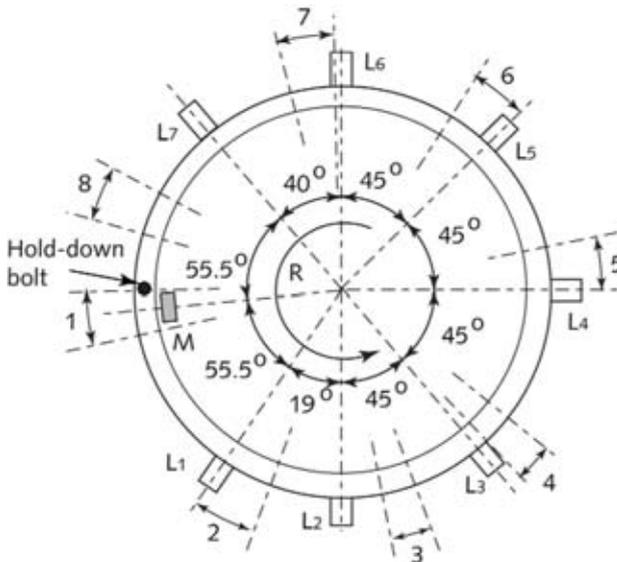
Figure 2.29 Layout of machine showing leg and bearing damage locations on the inner (fixed) bearing surface. The L numbers represent support leg locations, M is the motor drive location, R is the machine rotation direction and the damage locations numbered 1 to 8 were measured arbitrarily from the first hold-down bolt near the location of the motor drive

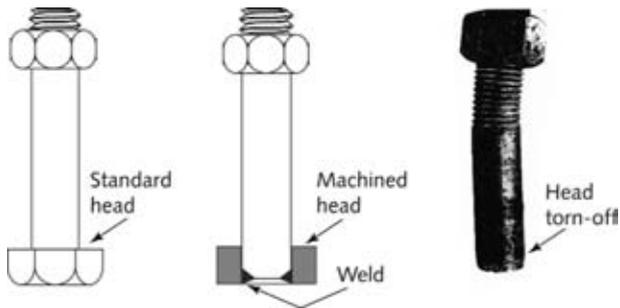
Figure 2.34 The damaged king-pin bolt and schematic sketches of a standard bolt and one similar to that manufactured by Blunt

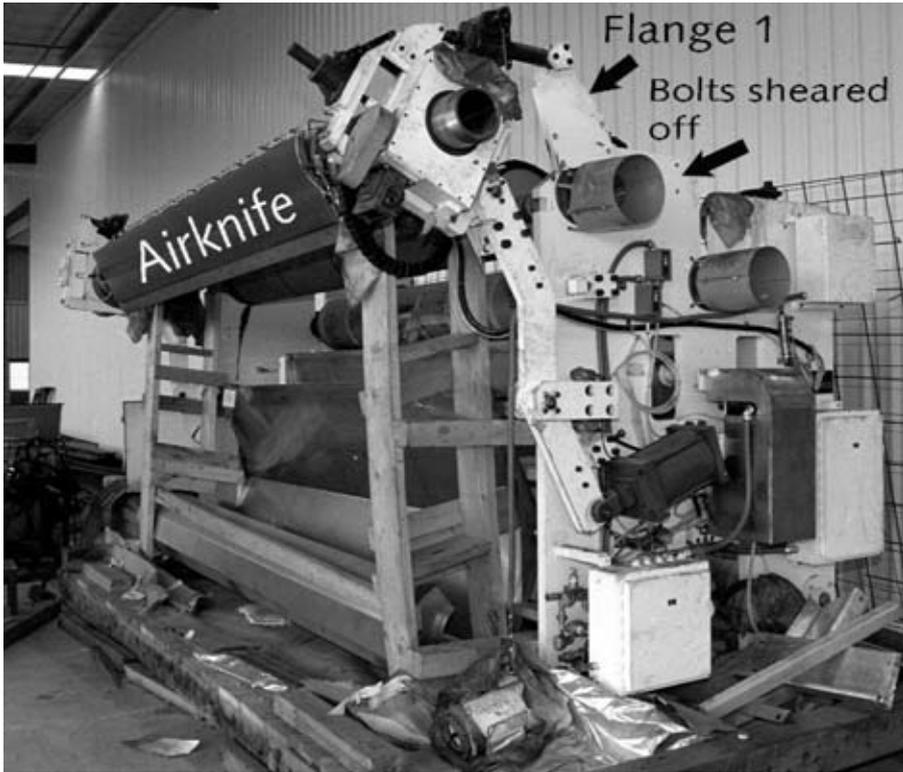
Figure 2.41 General view of the partially unpacked airknife machine in its damaged packaging

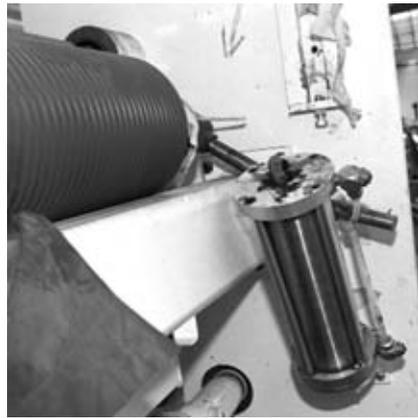
Figure 2.43 View showing roller dislodged from its bearing and damaged air cylinder

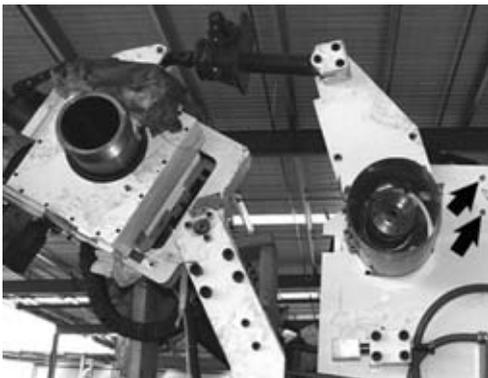
Figure 2.44 Airknife support head and its various adjustments. The arrows show where the flange bolts sheared off

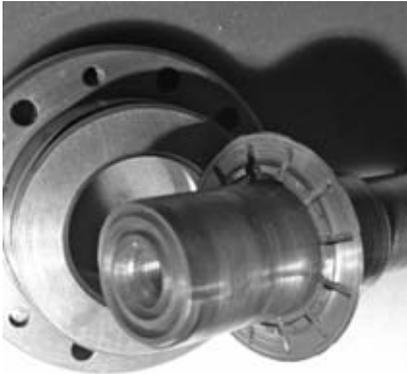
Figure 2.51 Heavily worn thrust face on high-speed journal

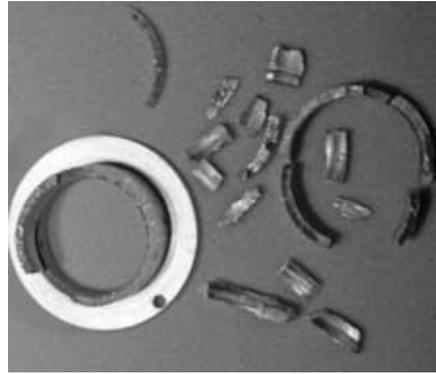
Figure 2.52 Components of bearing shell recovered from seized compressor

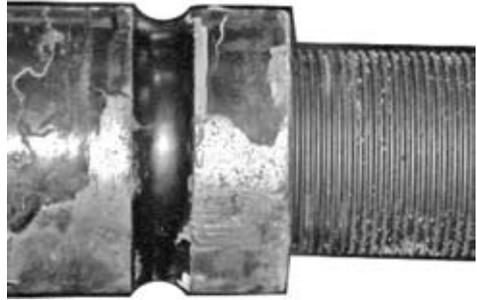
When the steering linkages of the flipped tractor were examined, it was found that the steering knuckle had been pulled out of the main steering track rod. This track rod is a heavy tubular component that connects the steering arms of the two front wheels on the tractor (see the item marked Z in diagram (b) of Figure 2.57). Three-degree-of-freedom ball joints on the steering knuckle (item marked E in diagram (a) of Figure 2.57) allow for the necessary motion freedoms required for steering the front wheels. The screw adjustment of the steering knuckle permits the camber of the front wheels to be adjusted. Camber is the angle the plane of the wheel relative to the vertical plane and is used to control steering forces.

Figure 2.59 Redesigned track rod end as found on flipped tractor

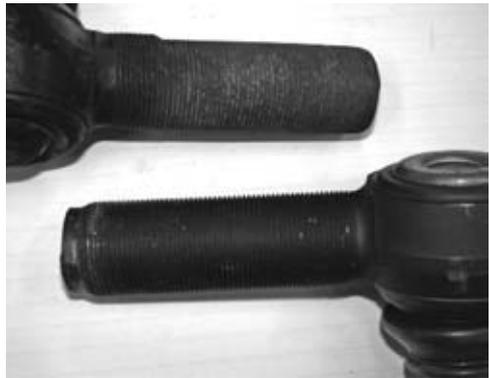
Figure 2.61 Worn knuckle (top) and new knuckle (bottom)

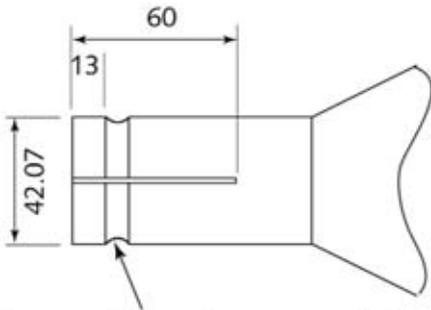
Approx. 10 mm dia groove embedded to 2.2 mm depth into track-rod surface

Figure 2.62 Sketch of track rod end as found on flipped tractor

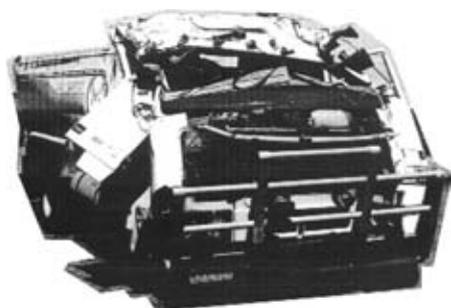
Figure 2.67 The damaged tipper owned and driven by Baritone

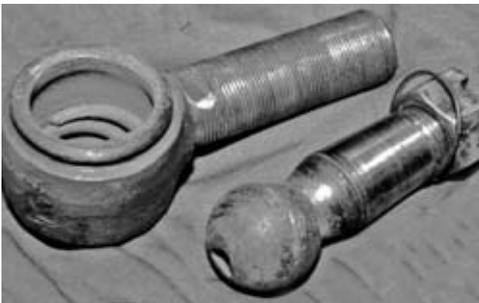
Figure 2.71 shows the two major parts of the failed ball joint. The socket was found to be completely filled with local clay and had to be cleaned out for full metallurgical examination. Figure 2.72 shows the ball joint at the other end of the failed steering link. Figure 2.73 shows a schematic sketch through a typical ball joint used on Safedrive vehicles. In the investigation of the accident the nylon bushes were not recovered. Figure 2.74 shows some parts of the sealing boot recovered from the failed joint. Sealed ball joints are generally expected to last for many years. If the sealing boot remained intact then it would be reasonable to expect such joints to last the full lifetime of the vehicle. The dispute in this case resolved into the following two issues:

Figure 2.71 The failed ball joint on the steering link. The socket had been cleaned out for this photo

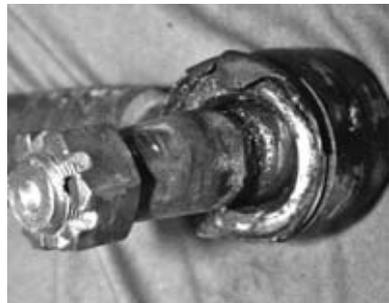
Figure 2.72 The ball joint at the other end of the steering link. Note the damaged grease boot

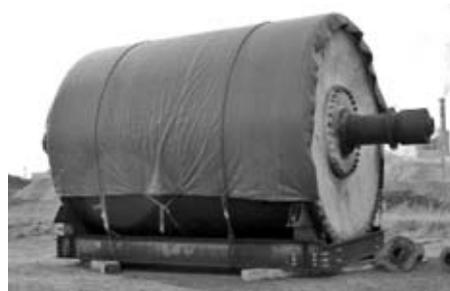
Figure 2.76 The discarded Yankee dryer stored on a field float at Marigold
