# 2

## Cases of Machinery Failure

### 2.1 The Cases

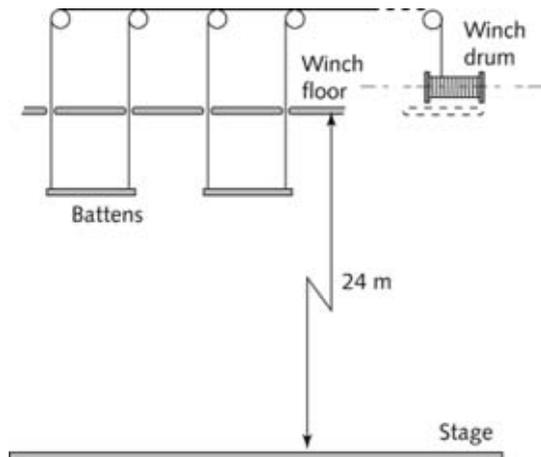
1. The winch motors and gearing were specified by the technical staff of the art centre complex architects *Forward Ltd.*
2. All winching equipment was imported from an American supplier, let us call them the *Ruckman Corporation*.
3. Original specifications of the flying battens called for a maximum loading of 200 kg and the system has been tested satisfactorily under static loading to nearly 500 kg.
4. Hardness tests of the shafts of the gearing system showed both input and output shafts to be 30% below specified values in material tensile strength.

Figure 2.2 Schematic partial view of the flying batten and winch system

5. American ASME standards for shaft design. This evaluation showed the shafts to be undersized by approximately 8%.
6. The failed winch shaft was found to have failed in fatigue and machining roughness on this shaft was identified as the originating cause of the eventual failure.

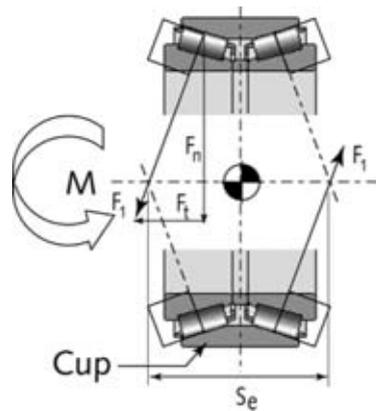
Figure 2.11 Schematic view of the main bearing indicating terminology

Figure 2.11 is a schematic view of the TBM main bearing, a double row taper roller bearing manufactured by the Torrington Corporation, estimated to cost \$20,000 in 1975, at the time of the accident.

In single row taper roller bearing terminology the outer race of the bearing is known as the *cup* and the inner race including the roller assembly as the *cone*. These terms are assigned to the bearing due to their overall physical shapes. In the *MRTA* failure it was the front section of the outer race (part of the cup) of the main bearing that broke away to permit the cutting head to fall out of its support. Figure 2.11 also indicates the types of loads acting on the bearing. Quite apart from the direct thrust load imposed on the bearing, resulting in the direct forces  $F_1$  being carried on the outer race (cup), the moment  $M$  on the machine head induces extra varying loads on these bearing cups. The weight of the machine head, outside the central plane of the bearing results in an added moment being carried by forces on the bearing cup.

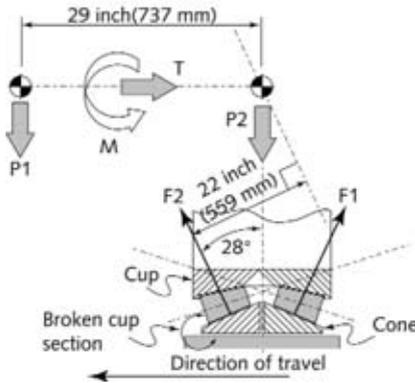
Figure 2.14 Detailed load model of TBM bearing used in analysis of retaining ring deflection

Figure 2.14 is a schematic representation of the various loads acting on the bearing and in turn on the retainer ring designed to maintain the bearing in its mounting within the deflection limits specified by the manufacturers. Torrington's specification for this bearing was a maximum tilt of the central plane of the bearing of 0.5 minutes of arc. Consequently it was necessary to investigate the mounting geometry and its flexibility.

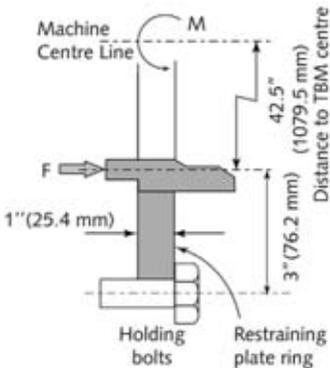
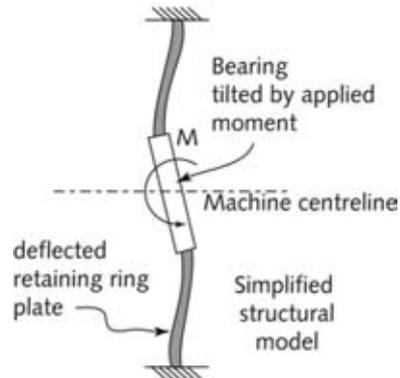
Figure 2.16 Bearing retainer ring dimensions

Figure 2.17 Simplified model of the retainer ring deflection

Figure 2.16 shows a partially dimensioned section through the retainer ring and Figure 2.17 is a simplified structural model adopted for the evaluation of flexure of the retainer ring. It was modelled as a simple constant-thickness annular circular plate with a built-in outer edge (the holding bolt pitch circle), with a moment applied at the annulus.<sup>2.9</sup>

Figure 2.18 shows (approximately to the same scale as the original retainer shown in Figure 2.15) the sectional drawing with the modified bearing retainer. Clearly, the new retainer ring has been substantially increased in thickness, as a result of this investigation. Fortunately, there was sufficient space available in the original design to permit the replacement of the original retainer with this substantially thicker retainer ring.

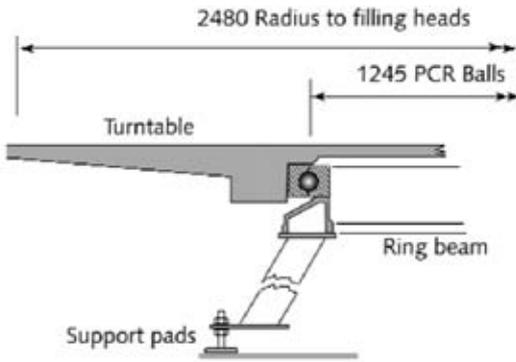
Figure 2.23 Schematic section of filler showing bearing mounting arrangement (not to scale)

GBF corporation. Figure 2.19 shows a typical stubby bottle, Figure 2.20 is a general view of the bottle filler at Tattaly, Figure 2.21 is a close-up view of filling stations and Figure 2.22 is a sample photo of the typical damage observed on the bearing races. Figure 2.23 is a schematic section through the filling machine showing the location of the failed bearing, nominally a KD600 *slewing -ring* bearing, with full details of its life and loading curves available from the *Rothe Erde Large-Diameter Antifriction Bearing Catalogue*. Figure 2.24 is a close-up photo of one of the legs and levelling pads on which the filling machine is supported. Figure 2.25 is a photo showing the underneath of the machine turntable and Figure 2.26 shows a photo of the balls and spacers of the bearing. These balls are made of hardened steel and in their travel inside the bearing they exert substantial local loading on the bearing surface. If the bearing race has any surface imperfections or some foreign particle imposed on it from lubricating grease contamination, the passage of these hardened balls over these imperfections or foreign matter will generate an exaggerated jarring loading on the bearing surface. On first inspection the surface damage to the bearing shown in Figure 2.22 was suggestive of this type of initiating process.

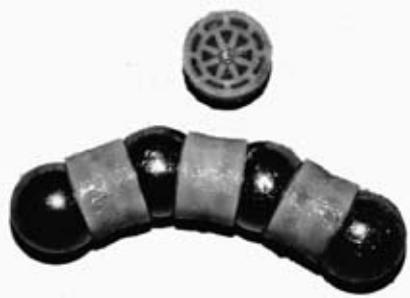
Figure 2.26 Ball and spacer arrangement

Figure 2.26 is a photograph of the 35 mm diameter balls and the plastic spacers used in the machine bearing. The bearing outer ring has a slot that permits the entry of balls into the bearing during assembly. Lubricant grease is pumped into the bearing at regular time intervals and there is a location on the bearing where the “new” lubricant extrudes “older” used lubricant from the bearing. Samples are taken from the extruded lubricant daily and analysed for metal content. When the content of metal shards in the grease exceeds some level specified by the manufacturer, the bearing is deemed to be near incipient failure. A few months after the failed original bearing was replaced by GBF engineers, the lubricating grease monitoring process showed up with unacceptably high metal particle content. It was this event that initiated the investigation described here.

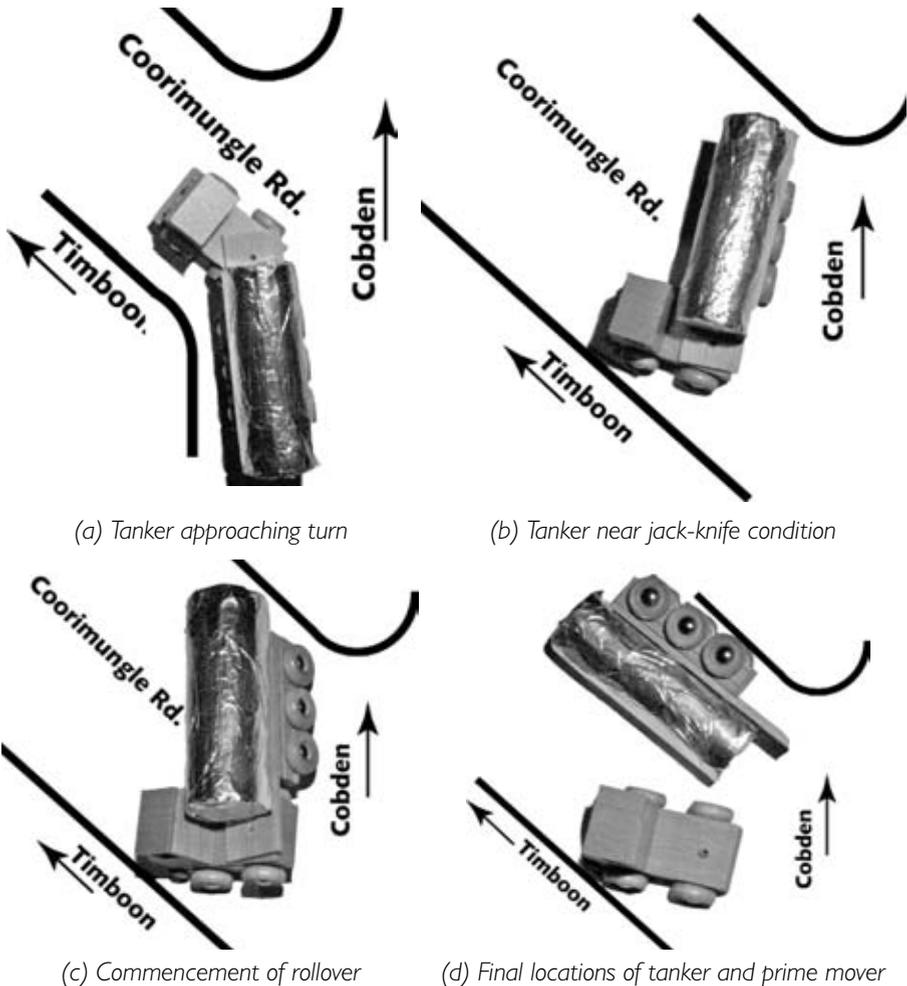
Figure 2.35 Model demonstration of the tanker rollover process (not to scale)

- (b) Tanker trailer begins to slide on wet road;
- (c) Inexperienced driver applies brakes;
- (d) Tanker trailer rolls and tears out kingpin bolt from the bottom plate of the hitch. Trailer and prime mover settle in locations indicated in the photo of Figure 2.35 (d). This was confirmed by the police report of the accident scene.

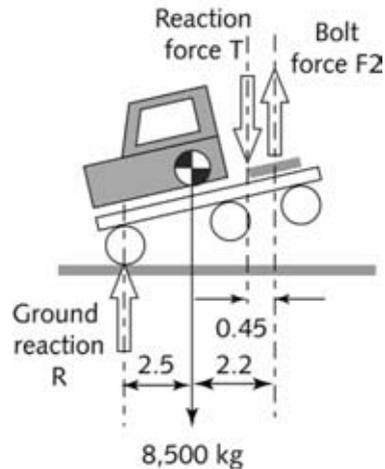
In Phase 2 of the rollover the moment acting on the top plate due to the rolling over of the trailer is  $F2 \times 0.45 \text{ Nm}$ .  $F2$  could have been estimated from the conjectured centrifugal forces acting on the rolling trailer at various road speeds and turn diameters. However, a simpler approach was to recognise that the bolt had indeed been torn out from its location and the twisting moment responsible for this was as indicated in Figure 2.37.

Figure 2.37 Phase 2 of the roll

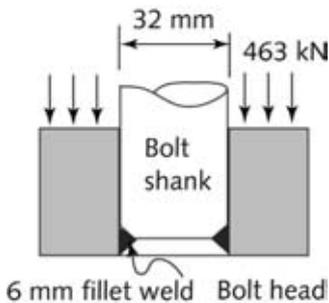
Figure 2.38 Schematic view of bolt head under load

Figure 2.38 is a schematic view of the bolt head under load during Phase 2 of the roll. The stress developed in the weld is given by<sup>2.17</sup>

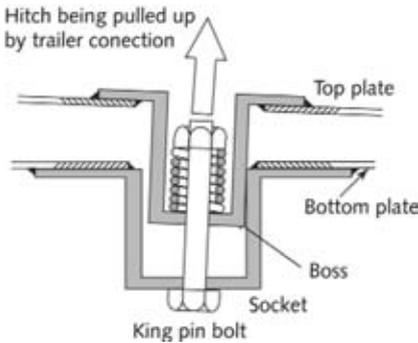
Figure 2.39 Greasy-plate hitch at its extreme displacement

This calculation does not take into account the failure of the bolt at its thread, where the root diameter is smaller than the shank diameter, and stress concentrations are introduced by the thread elements. The significance of the calculated stress on the bolt is that it would have failed in any circumstances whether it had been a standard bolt or a modified manufactured bolt. This bolt is not expected to carry substantial loading at any time other than when the hitch spring (refer to Figure 2.39) is fully compressed. In this condition the load is taken by the kingpin

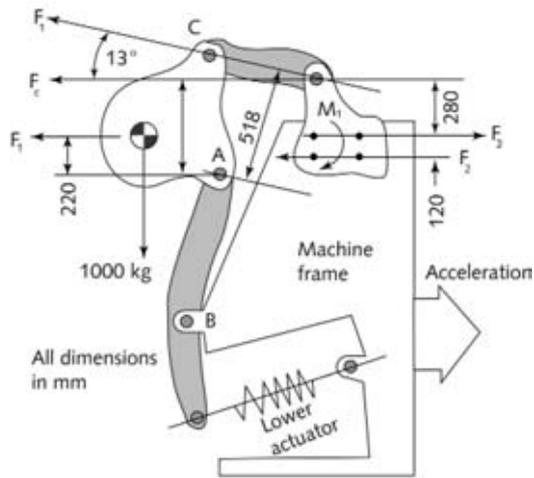
**(a) The Accident Scenario** – Figure 2.46 shows a side elevation of the airknife machine taken from a copy of drawings supplied by the Holker Corporation. The measurements were scaled from the drawing, using comparative dimensions measured on the actual Holker machine on site. Figure 2.47 is a simplified mechanism view of the moving parts of the airknife machine. The lower actuator is a pneumatic cylinder and in principle the air in this cylinder will act as a pneumatic spring until the lever arm pivoted at B hits a machine stop (see Figure 2.47). The following nomenclature is assigned to the analysis:

Figure 2.47 Simplified mechanism schematic of the major moving parts of the airknife machine indicating acceleration of the crated machine

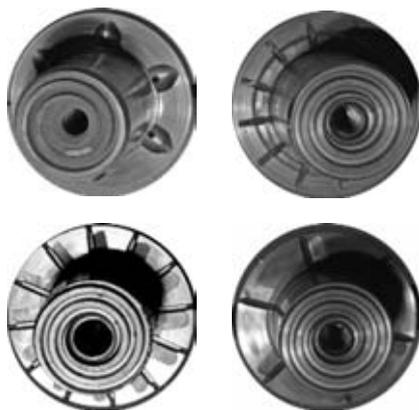
It is evident from Figure 2.54 that when overhauling the original bearing Electra chose to replace the original hydrostatic bearing with an angled pad design. There was no evidence suggesting the reasoning behind this decision, but it may be conjectured that obsolescence of the unit or inability to get replacement parts could have been responsible for the decision. From

Figure 2.54 Original thrust face compared to various alternatives tried by Electra

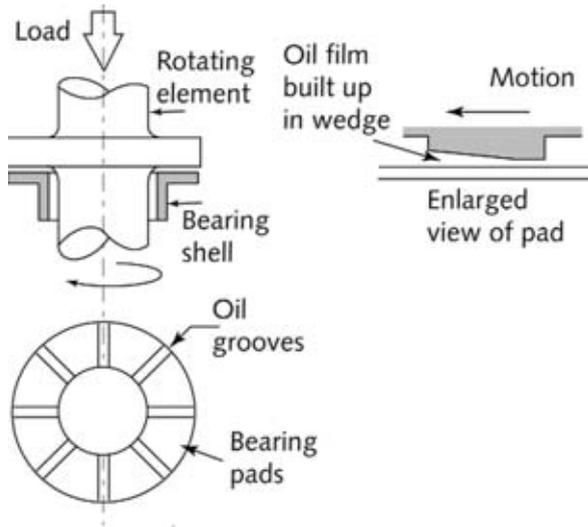
Figure 2.55 Angled pad thrust bearing geometry (schematic only)<sup>2.21</sup>

the several failed attempts at replacing the bearing it is also clear that Electra's design approach was one of trial and error rather than informed analysis. A reference to Neale's handbook on thrust pad design would have enlightened Electra to the real nature of angled pad thrust bearing design (refer to Figure 2.55). Moreover, tables in that publication would have advised them of the proper geometry for the loads and speeds encountered in the compressor. In the event the rather crude attempt at concocting such a bearing resulted in the ultimate seizure and failure of the compressor.

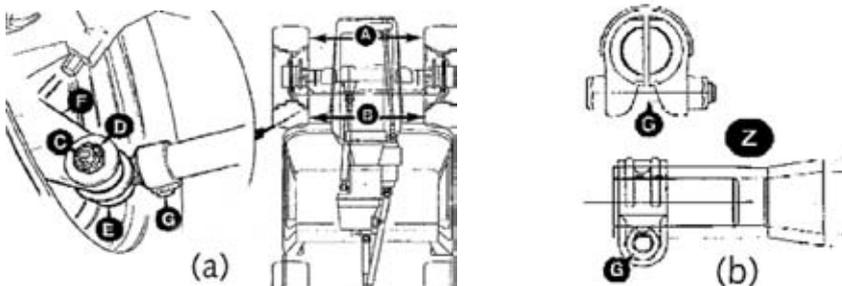
Figure 2.57 Maintenance instruction diagrams for the RS232 tractor

The advice offered to maintenance staff for adjusting the camber on the front wheels of the tractor is taken from the Bigbrother maintenance handbook for the RS232 tractor (refer to Figure 2.57).

2.5 Refit track rod end and firmly tighten nuts **D** and nut/bolt **G** which must be positioned horizontal as shown at **Z** and not vertical (see Figure 2.57 – diagram (b)).”

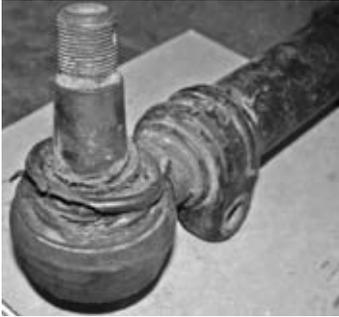
Figure 2.58 Original design of track rod (worn sample from Fillary)

When the steering linkages of the flipped tractor were examined, it was found that the steering knuckle had been pulled out of the main steering track rod. This track rod is a heavy tubular component that connects the steering arms of the two front wheels on the tractor (see the item marked Z in diagram (b) of Figure 2.57). Three-degree-of-freedom ball joints on the steering knuckle (item marked E in diagram (a) of Figure 2.57) allow for the necessary motion freedoms required for steering the front wheels. The screw adjustment of the steering knuckle permits the camber of the front wheels to be adjusted. Camber is the angle the plane of the wheel relative to the vertical plane and is used to control steering forces.

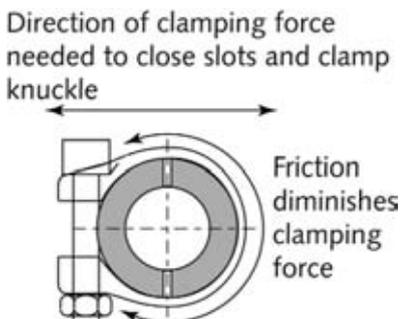
Figure 2.64 Schematic view of tube clamp with the clamping bolt oriented in the least desirable direction

From Figure 2.59 it is evident that the locking bolt of the tube clamp used on the new track rod end is constrained to be oriented at right angles to the tube axis by the bolt groove. However, the bolt is not constrained to be located at any specific orientation relative to the slot in the tube end (refer to Figure 2.62). It is this slot that should permit the clamping together of the tube end onto the steering knuckle thread. If the clamp bolt is not at right angles to these slots, the clamping force will be partly dissipated in clamp friction, the worst case being when the bolt is parallel to the plane of the slots (refer to Figure 2.64).

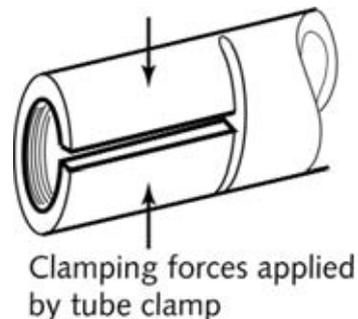
Figure 2.65 Schematic sketch of a pipe clamp designed to permit better grip on the steering knuckle thread

A more appropriate design for clamping the track rod end to the steering knuckle thread is seen in the sketch of Figure 2.65. This design permits clamping of the thread along substantial part of its length and would have avoided the problem experienced with the RS232 tractor. Interestingly, the

design shown in Figure 2.65 is well known and used in many engineering applications, though perhaps not in the farm machinery industry.

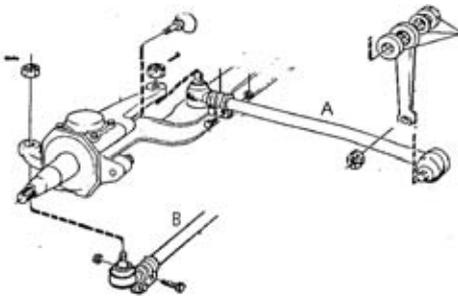
Figure 2.66 shows a typical tipper and Figure 2.67 is a photo of the damaged Safedrive tipper. Figures 2.68 and 2.69 show the steering linkage used on the tipper. Standard steering mechanisms use a simple Ackerman-type steering linkage based on the kinematics of the four-bar chain.<sup>2,24</sup> This linkage is designed to permit the outer steered wheel in the steering circle to roll further than the inner steered wheel, thereby eliminating tyre slip and wear. Figure 2.70 shows a schematic sketch of the Ackerman linkage. On right-hand-drive vehicles the input to the steering linkage is provided by the steering link, normally a short link with two ball joint ends (see the link marked A in Figure 2.68). It is this link that failed on the Safedrive tipper, causing the whole steering linkage to become free to move under the steering forces generated by the ground reaction on the tyres. Once the vehicle left the sealed road and moved onto the soft shoulder of the road, the front wheels would dig into the soft soil and turn at some steep angle to the direction of motion. The wheel dug into the dirt and became a pivot about which the vehicle rolled over. Police photographs at the scene showed the

Figure 2.68 A schematic view of the steering linkage of the tipper. The link marked A is the steering linkage and B is the drag link

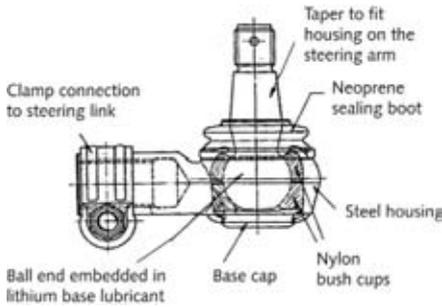
Figure 2.71 shows the two major parts of the failed ball joint. The socket was found to be completely filled with local clay and had to be cleaned out for full metallurgical examination. Figure 2.72 shows the ball joint at the other end of the failed steering link. Figure 2.73 shows a schematic sketch through a typical ball joint used on Safedrive vehicles. In the investigation of the accident the nylon bushes were not recovered. Figure 2.74 shows some parts of the sealing boot recovered from the failed joint. Sealed ball joints are generally expected to last for many years. If the sealing boot remained intact then it would be reasonable to expect such joints to last the full lifetime of the vehicle. The dispute in this case resolved into the following two issues:

Figure 2.73 Typical ball joint (not to scale) The nylon bushes were missing from the failed joint
